Massachusetts Office on Disability

Whitman Town Hall Accessibility Survey

Conducted by the Massachusetts Office on Disability

November 19, 2012

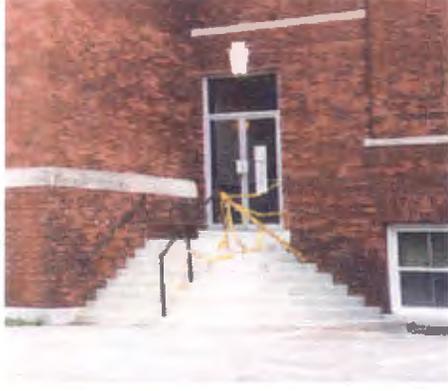
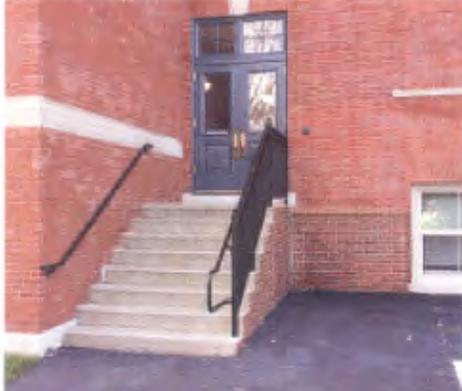
1999 Variance Granted	1999 Conditions	2012 Conditions	Work Performed 2009-2012
<p>East entrance: from parking lot grade to first floor. This entrance includes an exterior set of stairs and an interior set of stairs. Variance was granted based on excessive cost without substantial benefit*</p>

<ul style="list-style-type: none"> - Exterior doors replaced - Stairway width reduced - Possible resurfacing of stairs - Installation of handrail - Installation of sign reading: "Please use handicap entrance after 4:00pm." <p>NOTE: This doorway is open to the public during normal business hours until 4pm. There is a security card reader installed but at the time of survey the door was unlocked.</p>
<p>West entrance: under the porte-cochere. This entrance includes an exterior set of stairs and an interior set of stairs. Variance was granted based on excessive cost without substantial benefit*</p>

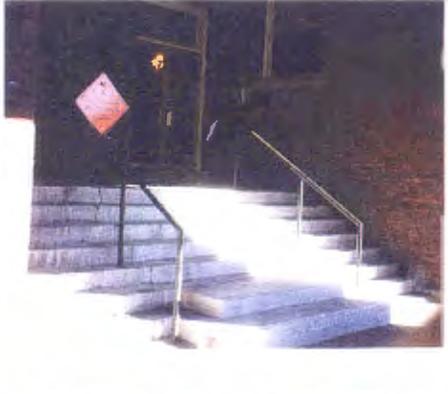
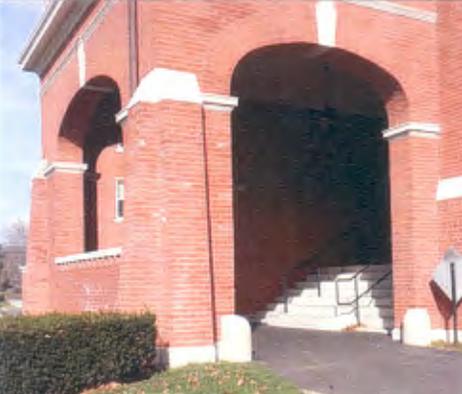
<ul style="list-style-type: none"> - Exterior doors replaced - Extensive restoration of porte-cochere* - Installation of handrail <p>NOTE: This doorway is open to the public during normal business hours.</p> <p>*It does not appear that the stairs were touched as part of this renovation.</p>

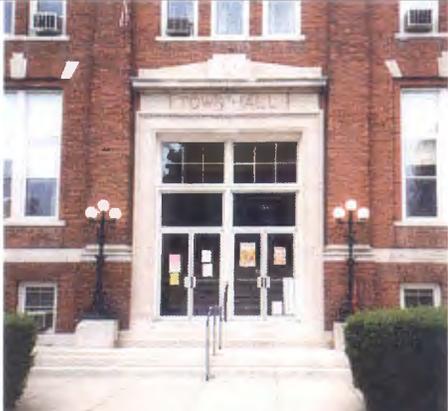
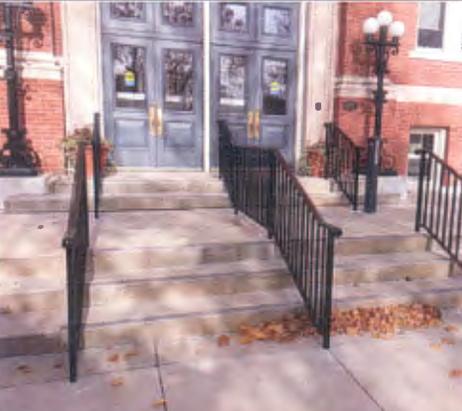
<p>South entrance: The ceremonial entrance to the building. This entrance includes an exterior set of stairs and an interior set of stairs. Variance was granted based on excessive cost without substantial benefit*</p>

<ul style="list-style-type: none"> - Exterior doors replaced - Resurfacing of interior stairs - Installation of exterior handrail - Installation of interior handrail - Installation of automatic door openers <p>NOTE: This doorway is open to the public during normal business hours.</p>

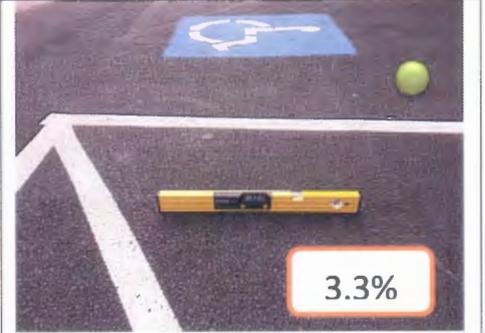
Current Conditions/Location	521 CMR Rev. 2006 (AAB)	ADAAG	Pictures / Notes
<p>There are a total of four designated accessible parking spaces for approximately 25 standard spaces. All four designated accessible parking spaces and access aisles have non-compliant slopes ranging from 2.2% - 4.6%</p>	<p>23.4.3 Slope: Parking spaces shall be <i>level</i> with surface slopes not exceeding 1:50 (2%) in all directions.</p> <p>23.4.6 d. <i>Access aisles</i> shall be <i>level</i> with surface slopes not exceeding 1:50 (2%) in all directions.</p>	<p>4.6.3...Parking spaces and access aisles shall be level with surface slopes not exceeding 1:50 (2%) in all directions.</p>

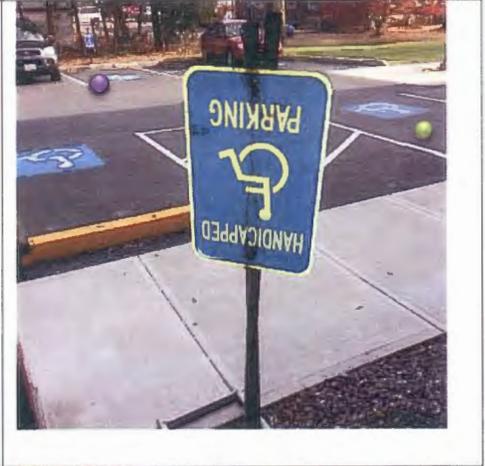
<p>Note location in image below</p>
<p>In one location, the designated accessible parking sign was turned around and not visible from the parking lot.</p> <p>Signs are not permanently located in the ground.</p>	<p>23.6.1 A sign shall be located at the head of each space and no more than ten feet (10' = 3048mm) away, and at <i>accessible</i> passenger loading zones and may also include wording identifying its use.</p> <p>23.6.4 Such signs shall be permanently located at a height of not less than five feet (5'), nor more than eight feet (8') to the top of the sign.</p>	<p>4.6.4* Signage. Accessible parking spaces shall be designated as reserved by a sign showing the symbol of ...Such signs shall be located so they cannot be obscured by a vehicle parked in the space.</p>

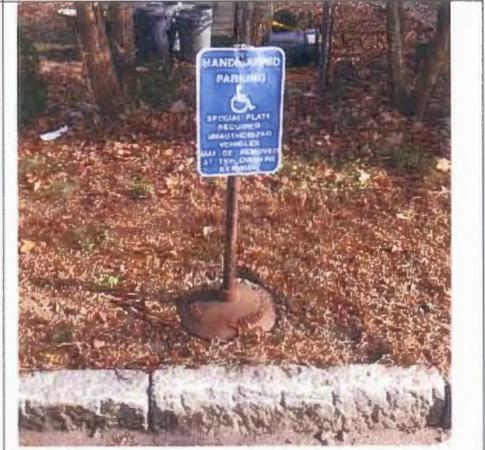
<p>In two locations, the designated accessible parking signs were mounted at 46" from parking surface to the top of the sign.</p> <p>Signs are not permanently located in the ground.</p>	<p>23.6.4 Such signs shall be permanently located at a height of not less than five feet (5'), nor more than eight feet (8') to the top of the sign.</p>	<p>4.6.4* Signage. Accessible parking spaces shall be designated as reserved by a sign showing the symbol of ...Such signs shall be located so they cannot be obscured by a vehicle parked in the space.</p>

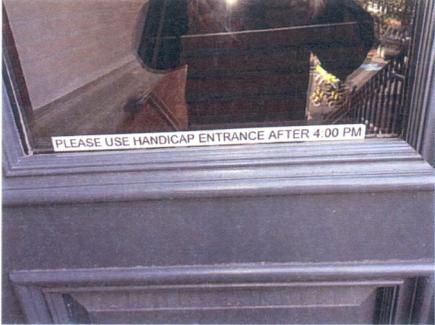
<p><i>Vertical Access/South Entrance</i> There is no vertical access provided at the south entrance as shown on page 2, entrance summary.</p>			
<p><i>Signage/East Entrance</i> The existing sign which reads, "PLEASE USE HANDICAP ENTRANCE AFTER 4:00PM", is not placed with the language or intent of guiding one to an accessible entrance. The sign cannot be read from the bottom of the stair.</p>	<p>25.6 SIGNAGE Any <i>entrance/exit</i> of a <i>facility</i> not <i>accessible</i> by persons in wheelchairs shall have a sign clearly indicating the location of the <i>accessible entrance/exit</i>.</p>

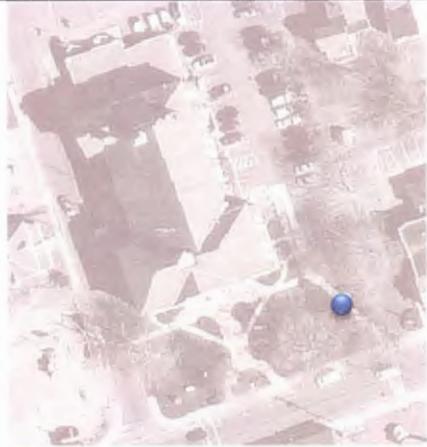
Current Conditions/Location	521 CMR Rev. 2006 (AAB)	ADAAG	Pictures / Notes
<p><i>Signage / South Entrance</i> The only indication for the location of the accessible entrance is a sign which reads, "Accessible Ramp". The sign is located on a path more than 25' away from the south entrance.</p>	<p>25.6 SIGNAGE Any entrance/exit of a facility not accessible by persons in wheelchairs shall have a sign clearly indicating the location of the accessible entrance/exit.</p>

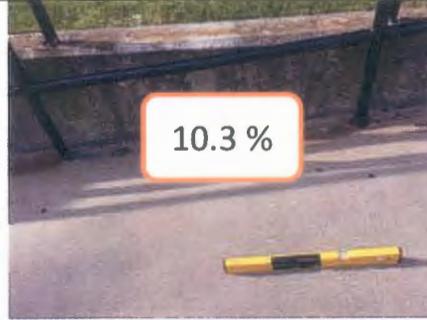
<p>10.3 %</p>

<p>● Approximate location of sign.</p>
<p><i>Ramp / East Basement Entrance</i> The ramp to the east basement entrance was recorded to have the following running slopes: 10.4%, 8.8%, 9.1%, and 10.3%.</p>	<p>24.2.1 The least possible slope should be used for any ramp. The maximum slope of a ramp shall be 1:12 (8.3%). (There is no tolerance allowed on slope, Refer to 521 CMR 2.4.4d)</p>	<p>4.8.2* Slope and Rise. The least possible slope shall be used for any ramp. The maximum slope of a ramp in new construction shall be 1:12.</p>

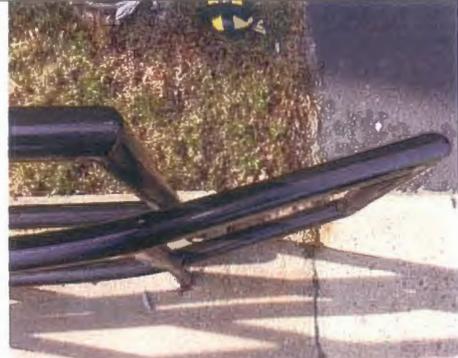
<p><i>Handrail / E. Basement Entrance</i> The handrails do not extend 12" past the top edge of the ramp.</p> <p>The hand rail is broken on one side of the ramp at the top.</p>	<p>24.5.4 Extensions: Handrails shall extend at least 12 inches (12" = 305mm) beyond the top and bottom of the ramp and shall be parallel with the floor or ground surface (See Fig. 24d), except where the extension would cause a safety hazard.</p> <p>2.6 MAINTENANCE OF ACCESS FEATURES</p>	<p>4.8.5... (2) If handrails are not continuous, they shall extend at least 12 in (305 mm) beyond the top and bottom of the ramp segment and shall be parallel with the floor or ground surface (see Fig. 17).</p>

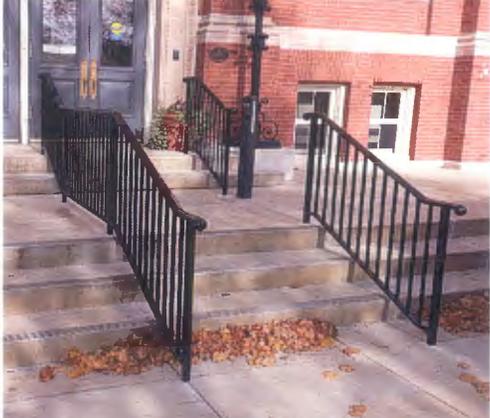
Current Conditions/Location	521 CMR Rev. 2006 (AAB)	ADAAG	Pictures / Notes
<p><i>Handrail / South Entrance</i> The newly installed handrails are flat instead of round or oval in shape.</p> <p>Gripping surface is interrupted by newel posts.</p>	<p>27.4.5 Shape: The handgrip portion of the handrail shall be round or oval in cross-section. <i>See Fig. 27e.</i></p> <p>27.4.6 Surface: The gripping surface shall be continuous so that a hand can move from end to end without interruption by newel posts or other obstructions, and shall be free of any sharp or abrasive <i>elements</i>.</p>	<p>4.26.2* Size and Spacing of Grab Bars and Handrails. The diameter or width of the gripping surfaces of a handrail or grab bar shall be 1-1/4 in to 1-1/2 in (32 mm to 38 mm), or the shape shall provide an equivalent gripping surface.</p>

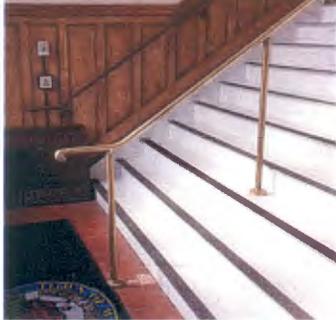
<p><i>Handrail / South Entrance</i></p> <p>Center handrail does not have an extension that is returned smoothly to the floor or post.</p> <p>Gripping surface is interrupted by newel posts.</p>	<p>27.4.6 Surface (see above)</p> <p>27.4.8 End condition: Ends of handrails shall be either rounded or returned smoothly to floor, wall, or post. Extensions on handrails which are not attached to walls shall be returned smoothly to the floor or a post.</p>

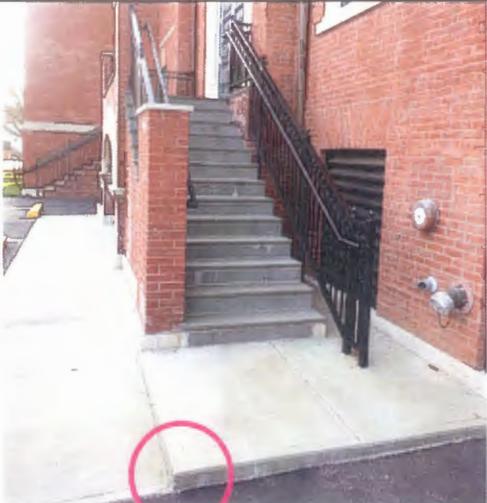
Current Conditions/Location	521 CMR Rev. 2006 (AAB)	Pictures / Notes
<p>It is assumed that the auditorium requires at least two means of accessible egress. The newly constructed east and west egresses do not meet 521 CMR rules and regulations.</p>	<p>20.11.1a. Where more than one means of egress is required under 780 CMR (The Massachusetts State Building Code) from any accessible space or element, each space or element shall be served by not less than two accessible means of egress.</p>

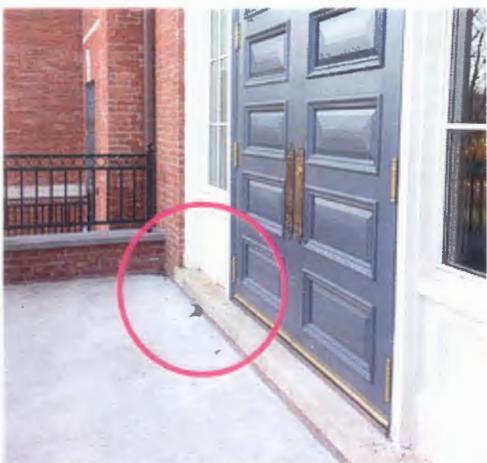
<p>The exit discharge does not provide a continuous path of travel from the exit to a public way.</p> <p>The balcony, while adjacent to the exit, is approximately 4" below the interior grade as shown on the image to the right.</p>	<p>20.11.2 The exit discharge shall provide a continuous path of travel from an exit to a public way by means of a walkway or a ramp.</p> <p>20.11.2b. in buildings where the grade at the level of exit discharge prohibits construction of either a walkway or a ramp, a portion of an exterior exit balcony located immediately adjacent to an emergency exit complying with 521 CMR 20.12.2 may be constructed as an area of rescue assistance.</p>

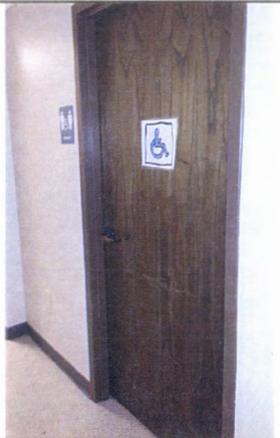
Current Conditions/Location	521 CMR Rev. 2006 (AAB)	ADAAG	Pictures / Notes
<p><i>Basement Unisex Toilet Room</i> Toilet room entry door has an opening force of 13 pounds.</p>	<p>26.8.1 Doors: These forces apply only to opening the door, not to the effort required to retract latch bolts or disengage other devices that may hold the door in a closed position.</p> <p>b. interior hinged doors: five lbs.</p>	<p>4.13.11* Door Opening Force. The maximum force for pushing or pulling open a door shall be as follows: (b) interior hinged doors: 5 lbf (22.2N)</p>

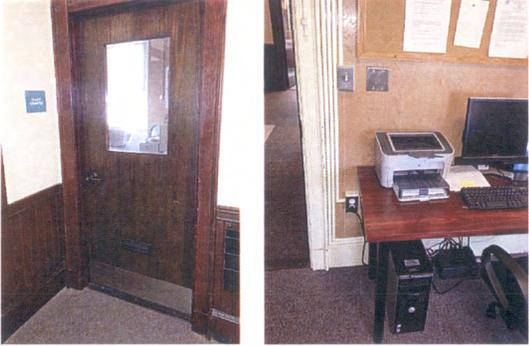
Current Conditions/Location	521 CMR Rev. 2006 (AAB)	ADAAG	Pictures / Notes
<p><i>Entry Door/Finance Committee</i> The required clear space on the push and pull/latch side of the door is restricted by furniture, equipment, and adjacent wall.</p>	<p>26.6.3 26.6.4 (See Selectman's Room)</p>	<p>4.13.6 (See Selectman's Room)</p>

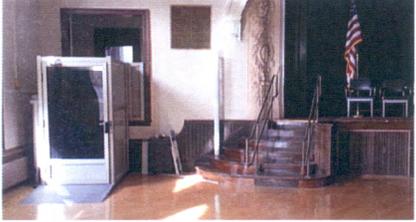
Current Conditions/Location	521 CMR Rev. 2006 (AAB)	ADAAG	Pictures / Notes
<p><i>Lift/Auditorium</i> The auditorium stage is accessed through a lift which requires travel through an ancillary room rather than directly onto the stage.</p>	<p>14.6 ACCESS TO PERFORMING AREAS Where access is provided to the stage from within the place of assembly, an <i>accessible route</i>, within the place of assembly, from the wheelchair seating locations, to the stage/performing area must be provided. <i>See Fig. 14b</i>. In addition, an <i>accessible route</i> that coincides with the route for performers must be provided to the backstage area.</p>

<p>NOTE: This lift was installed around 1999. The 1998 AAB rules and regulations state the following:</p> <p>14.6 ACCESS TO PERFORMING AREAS An <i>accessible route</i> shall connect wheelchair seating locations with performing areas, including stages, arena floors, dressing rooms, locker rooms, and other spaces used by performers. <i>See Fig. 14b</i></p> <p>It may be possible to have a variance granted by the AAB to have lift remain in place.</p>
